# Closeout Report for the Source Removal at the Trench 1 Site IHSS 108

RF/RMRS-99-302.UN

June 1999  
Revision 0

Project Name: Source Removal at Trench 1 - IHSS 108

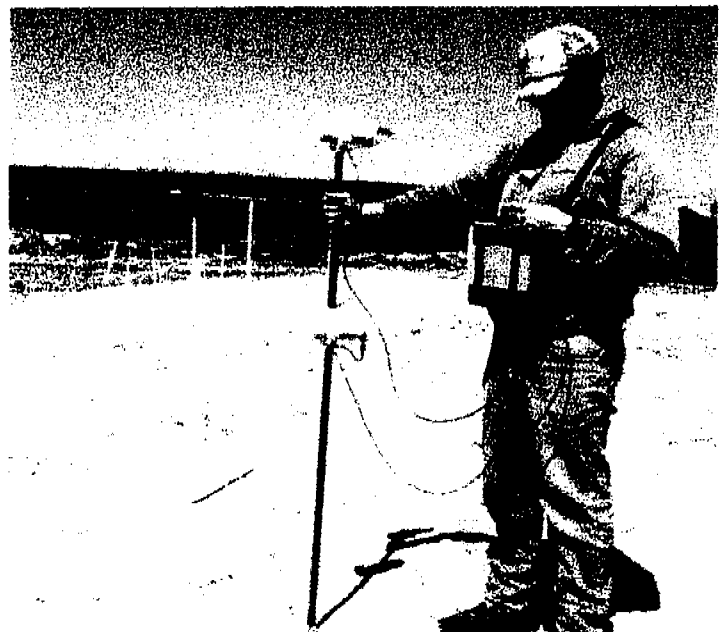
Figure 3 Proton Precession Magnetometer

Magnetic field measurements are typically made with proton precession magnetometers (Fig. 3), and both total magnetic field and the vertical gradient of the magnetic field can be measured simultaneously.

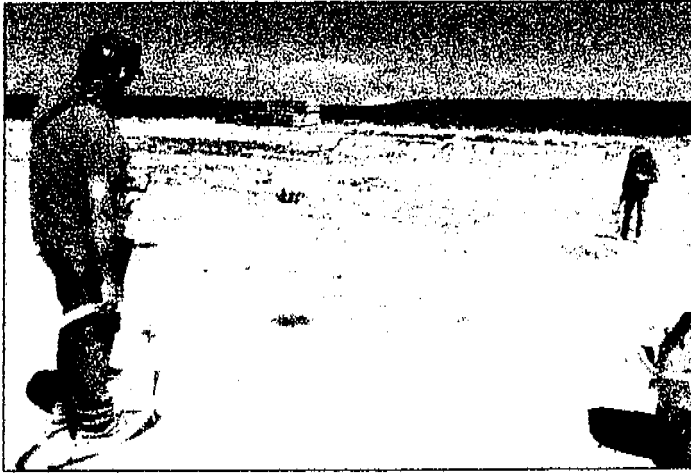
Figure 7 Geonics EM-34. Effective search depth depends on Tx-Rx separations and Coil orientation
